# Allied-Axis

THE PHOTO JOURNAL OF THE SECOND WORLD WAR

## Karl-Gerät 040 at the front

Panzerjäger I • SdKfz. 10 1-ton halftrack  
U.S. M2 Treadway Bridge • PzKpfw. IV Ausf. A  
Type 97 Japanese medium tank

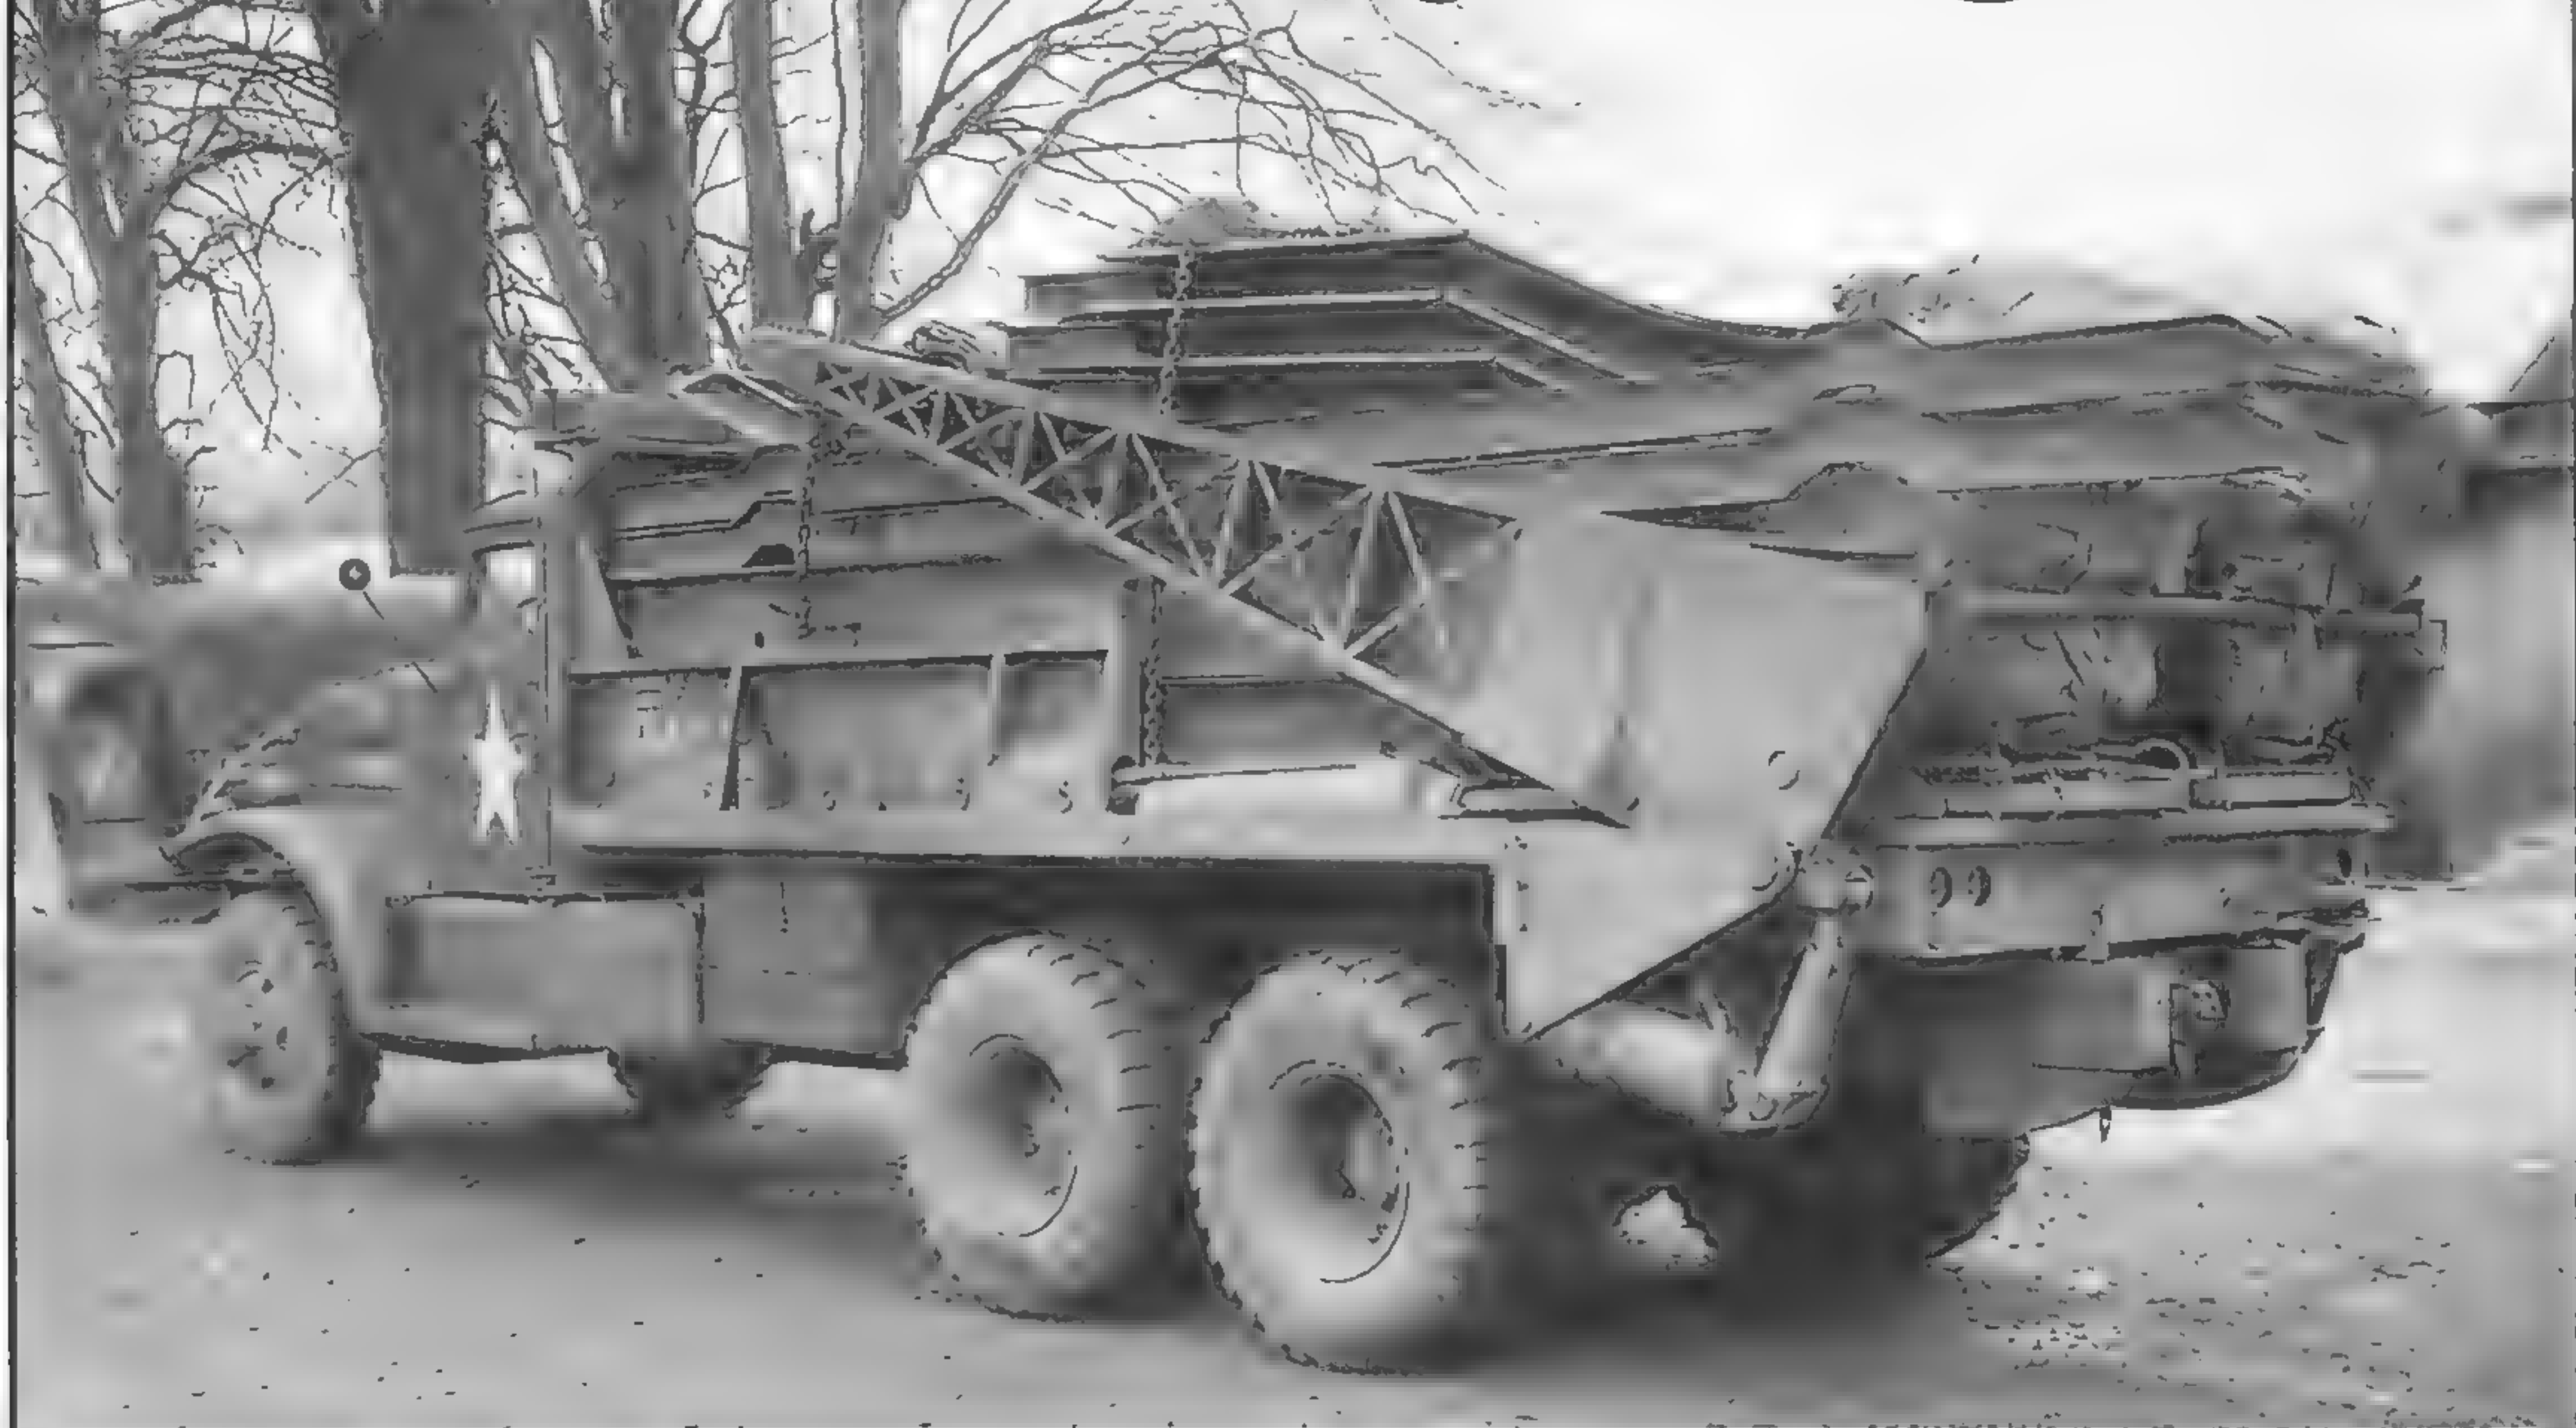
The M2 Treadway Bridge was a heavy pontoon bridge that had up to a 40-ton capacity. It could be deployed in almost any length and it was used over major river obstacles such as the Rhine and Moselle. The bridge was built using several purpose-built components including the U.S. M2 Pneumatic Pontoon, M2 Treadway Bridge sections (composed of two parallel girders with reinforced steel grating), M2 Treadway truss support (to support the sections over gaps) and access ramps for approaches. Generally, it would take five and a half hours to place a 362-foot section of

M2 Treadway during daylight and seven and a half hours at night. Engineers were expected to construct 50 feet of Treadway per hour. Many bridges were constructed in record time, as the following examples illustrate. To free the captured Ludendorff Bridge for repairs, the 291st Engineer Combat Battalion, assisted by the 988th and 998th Engineer Treadway Bridge Companies, began erecting a 1,032-foot Class-40 steel Treadway bridge just south of the Ludendorff Bridge on March 10, 1945. It opened to traffic on March 11 and was the first

American floating bridge over the Rhine. **Above:** Brockway, White, Ward LaFrance and FWD all produced bridge erector trucks which were used for transporting bridging components and for the erection of bridges, both pneumatic and fixed. Approximately 3,075 were produced and were all very similar. This photograph shows a Brockway Model B666 Treadway truck with hardtop. It was a 6-Ton, 6x6-cargo

truck with a double jib gantry operated by four hydraulic cylinders powered by the truck's engine. The 4-ton gantry was controlled from a platform at the front of the cargo body. A double drum front winch, snatch block and rear fairlead allowed for extended lifting and lowering of Treadways and equipment from the rear. (NARA)

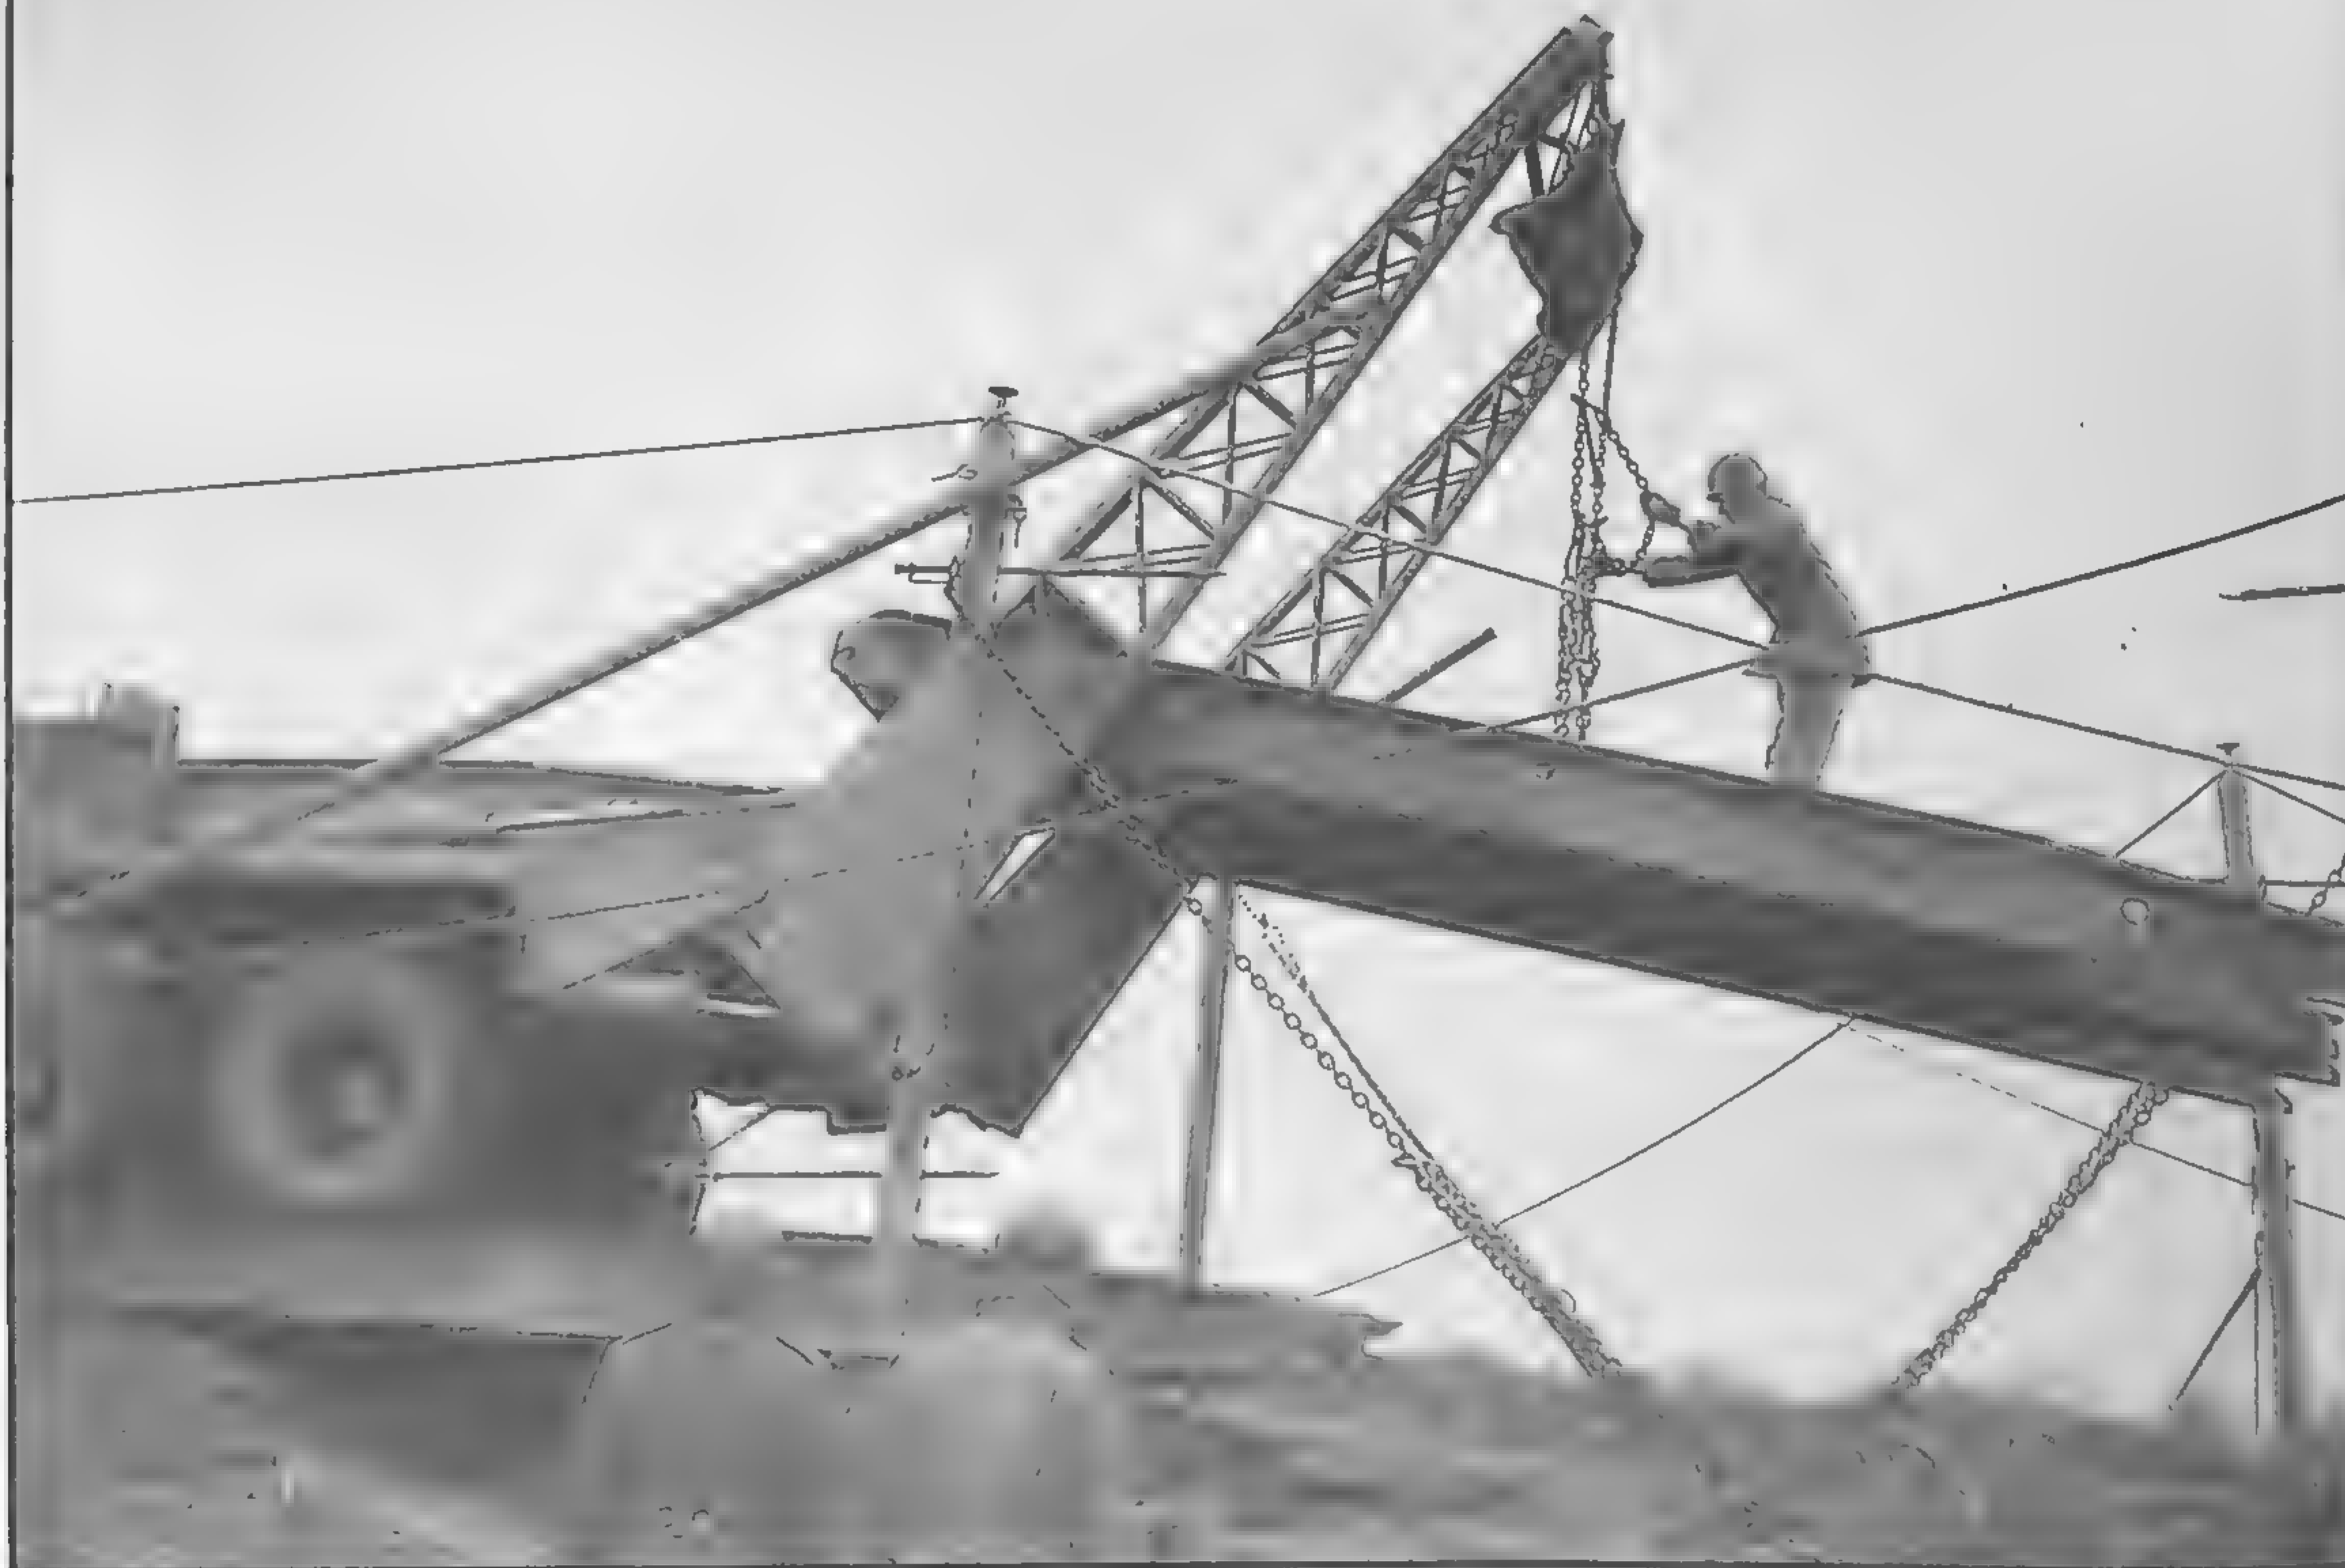
Two Treadways not connected by spacing hooks being attached to a bridge section. Once in position, two 4 5-foot connecting pins are driven into the connecting pinholes and the Treadway surface is extended. A single pin would allow the last section to articulate on the riverbank. The gantry operator can be seen at the far left near to the tarpaulin. (NARA)

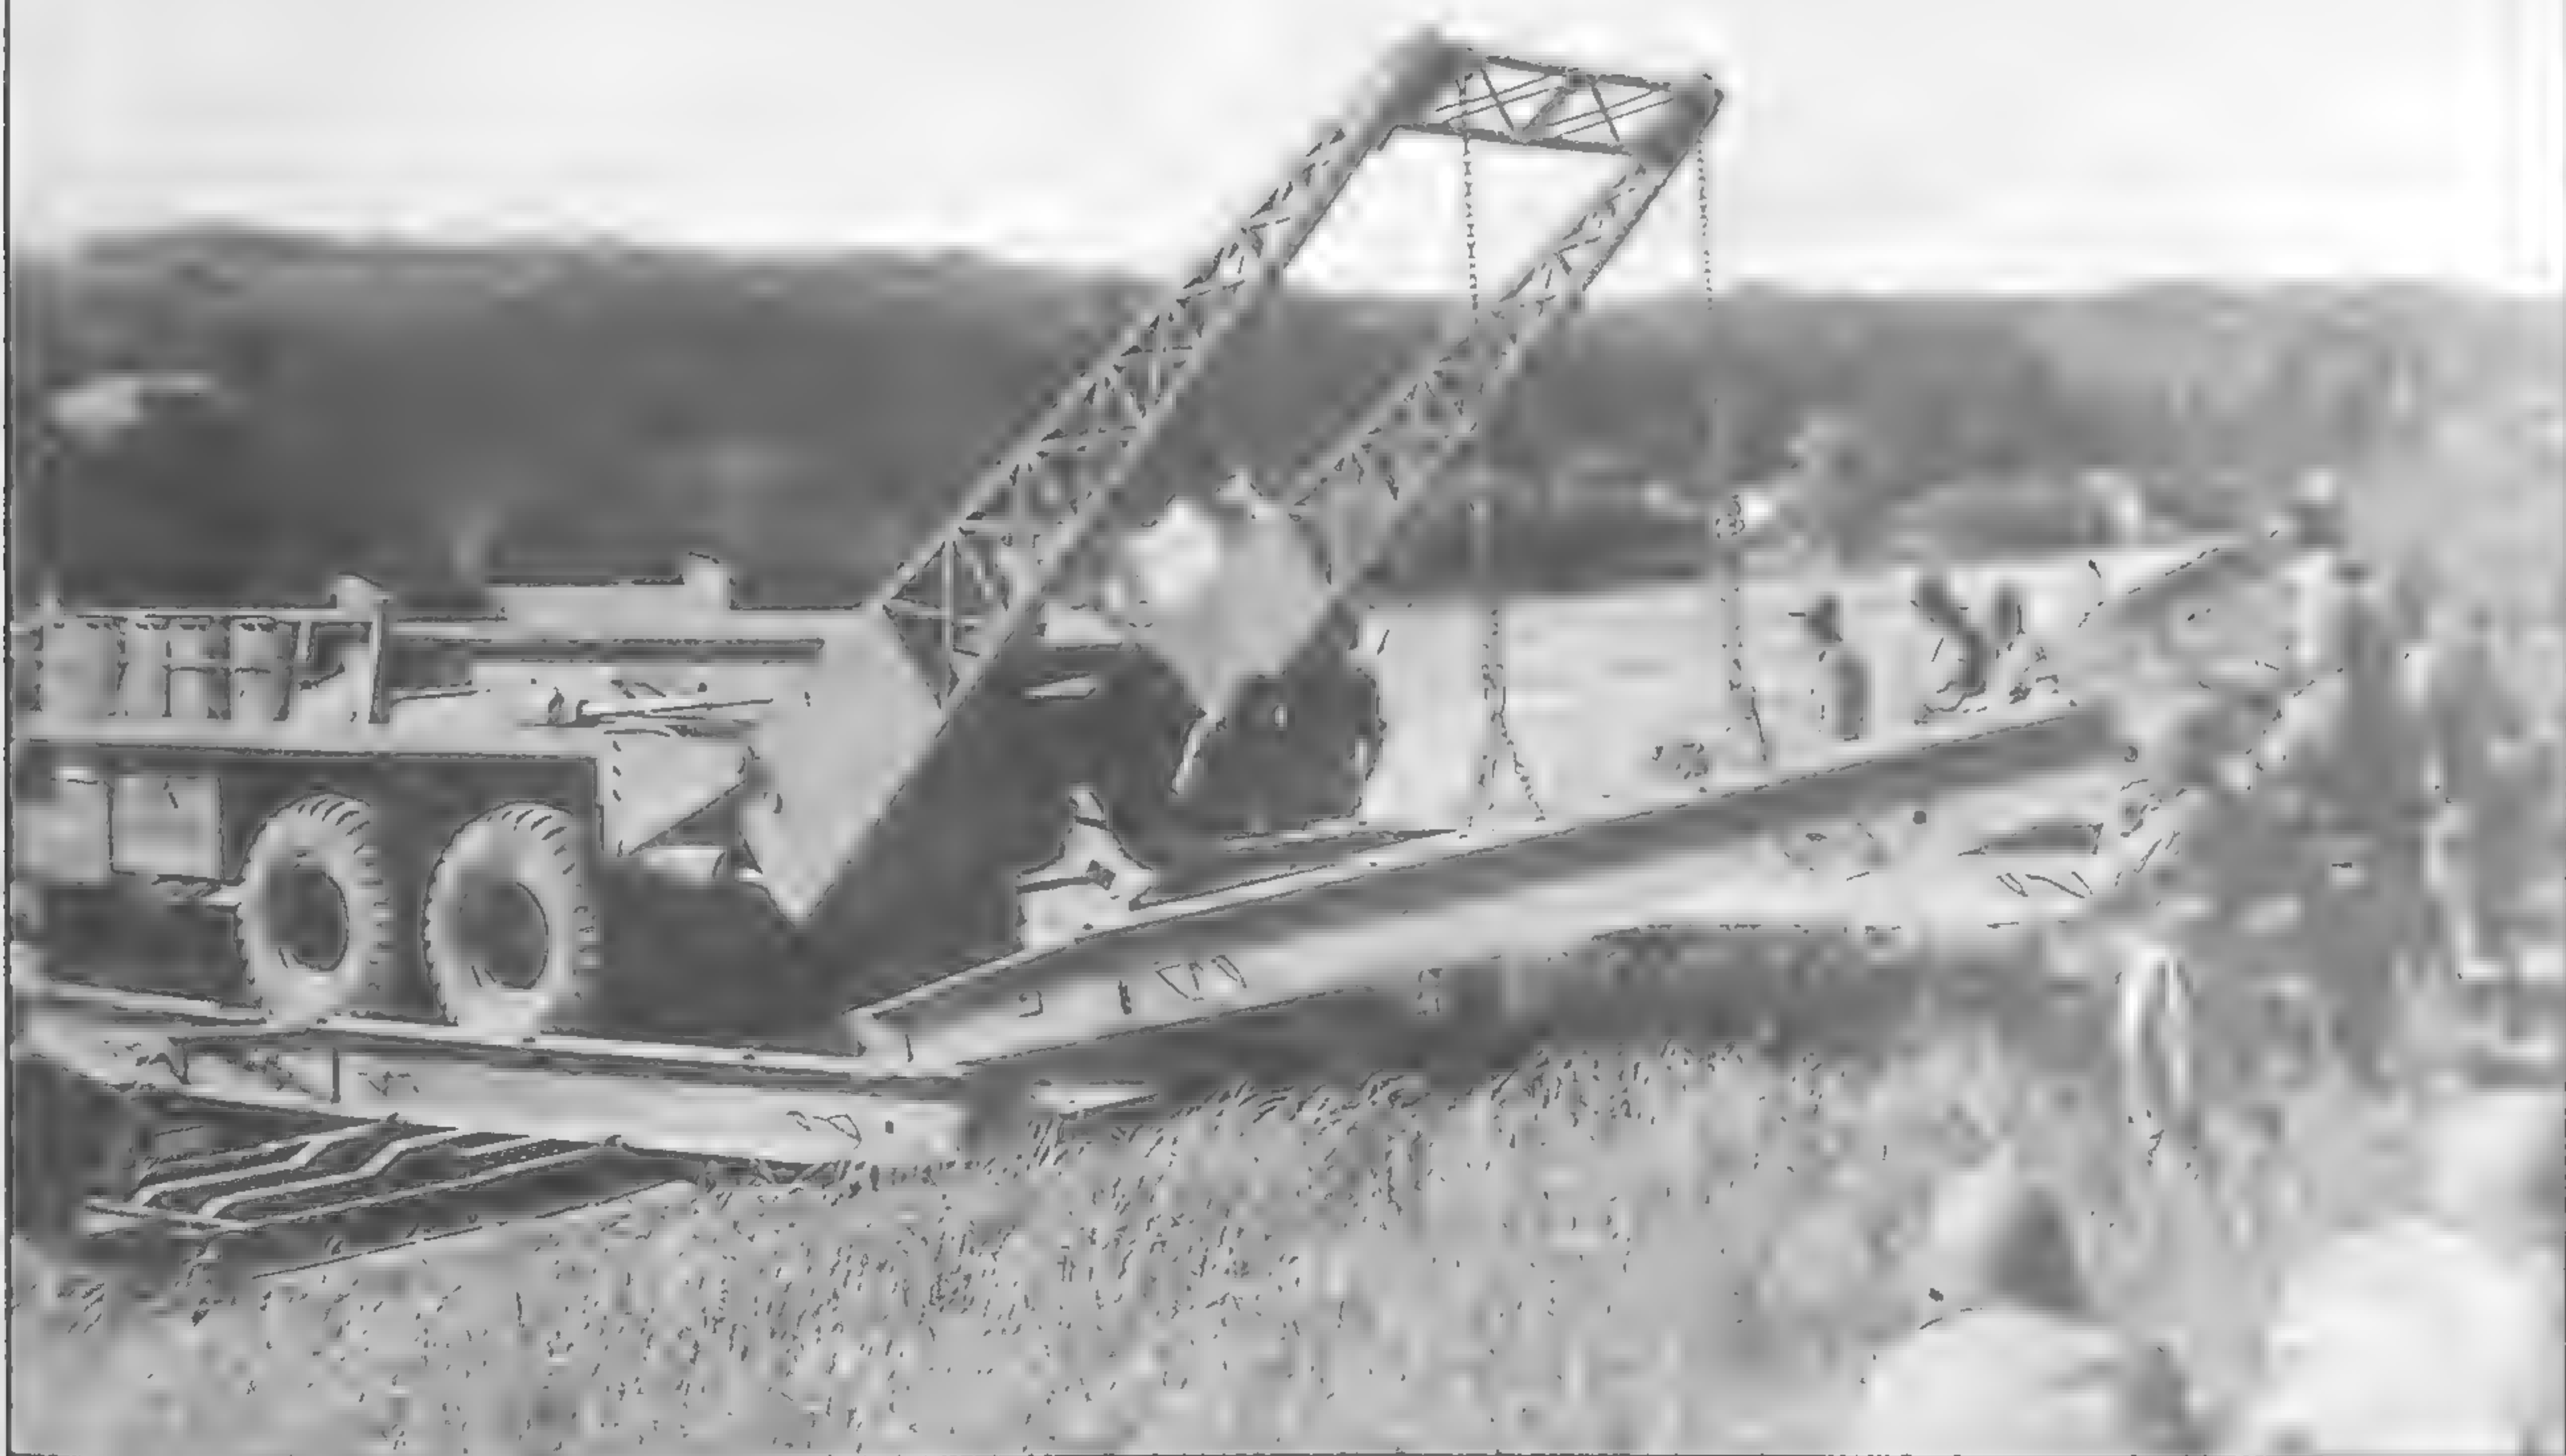
Six interior bearing plates and four saddle beams were attached to form a partial saddle. The saddle is being set onto a raft with the secured center tube in position. The saddle was then fastened to the float by straps attached to D-rings. Engineers below the gantry near the other rafts are attaching the end bearing plates. The pneumatic float is made of rubberized canvas; it is 8 feet 3 inches wide, 33 feet long and 33 inches deep with a floor. (NARA)

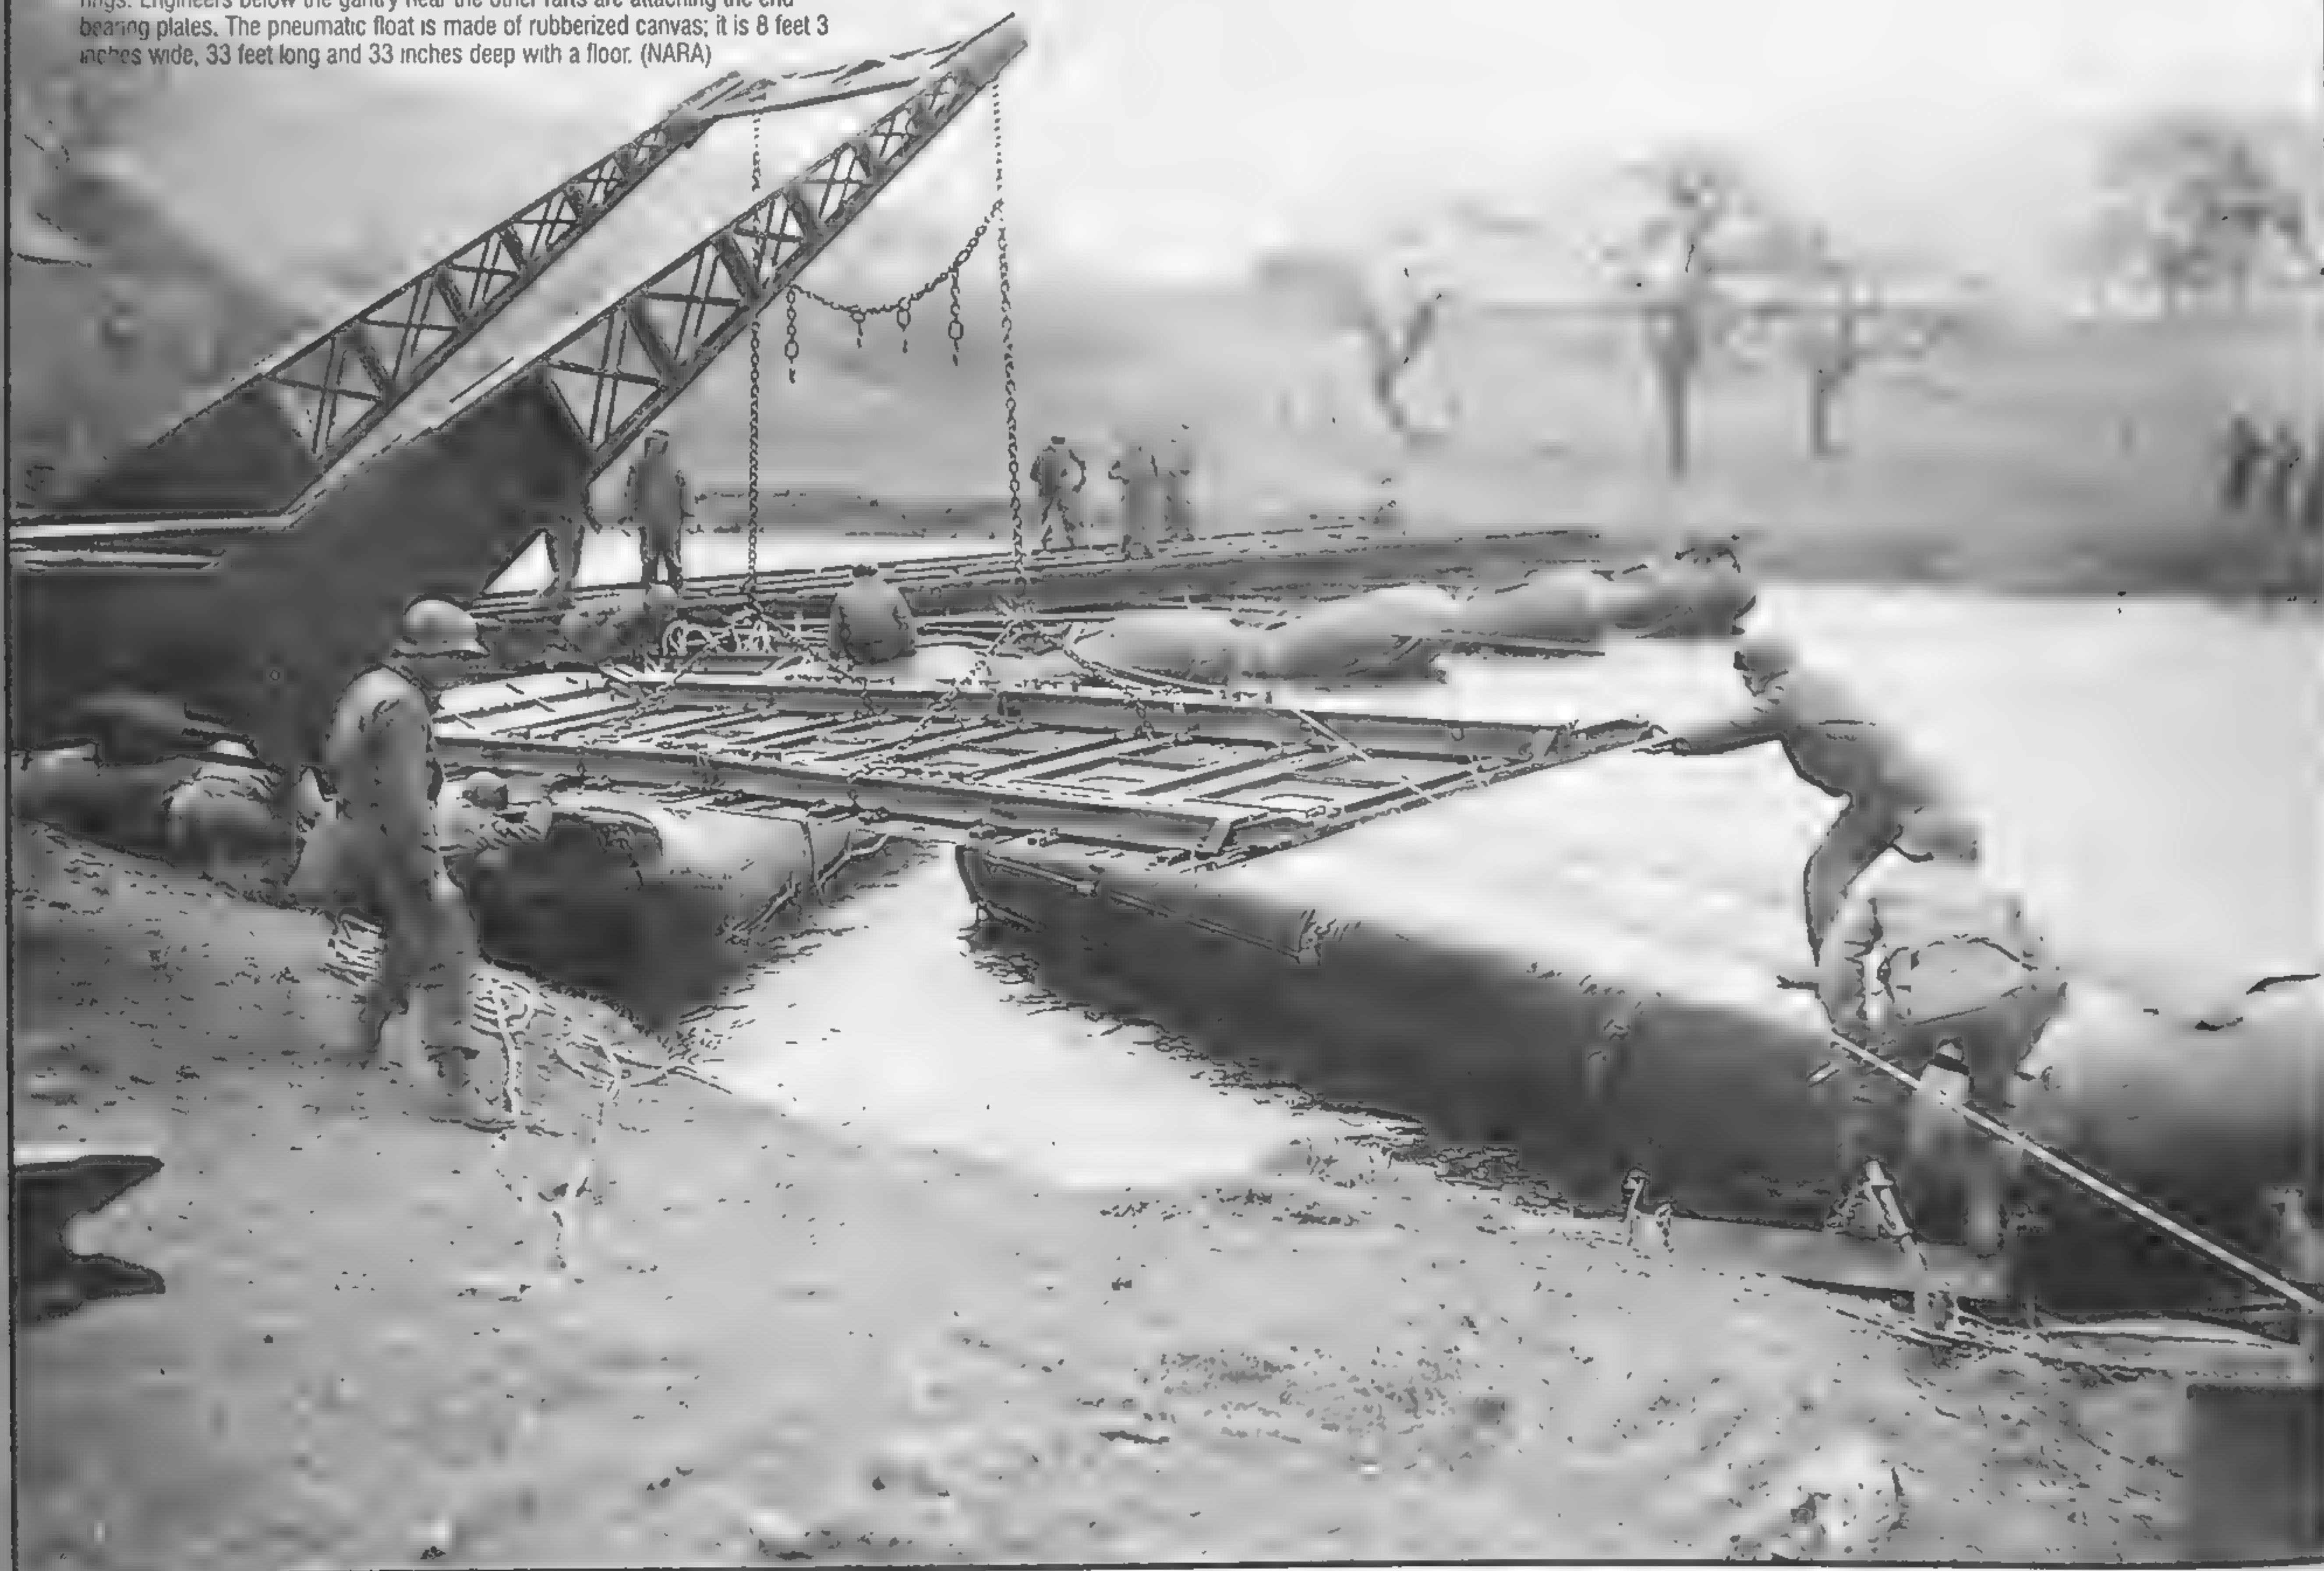
A Steel-Treadway M2 Bridge under construction to replace the destroyed bridge on the right. Two floating sections have been connected and are in the river. Note the 25-ton Le Roi compressor truck inflating a raft. The raft on the bank has the saddle in place and engineers are carrying one of the four saddle beams. The assembled raft in the water will then be floated to the end of the floating bridge and the erector truck will reverse and attach two Treadways. (NARA)

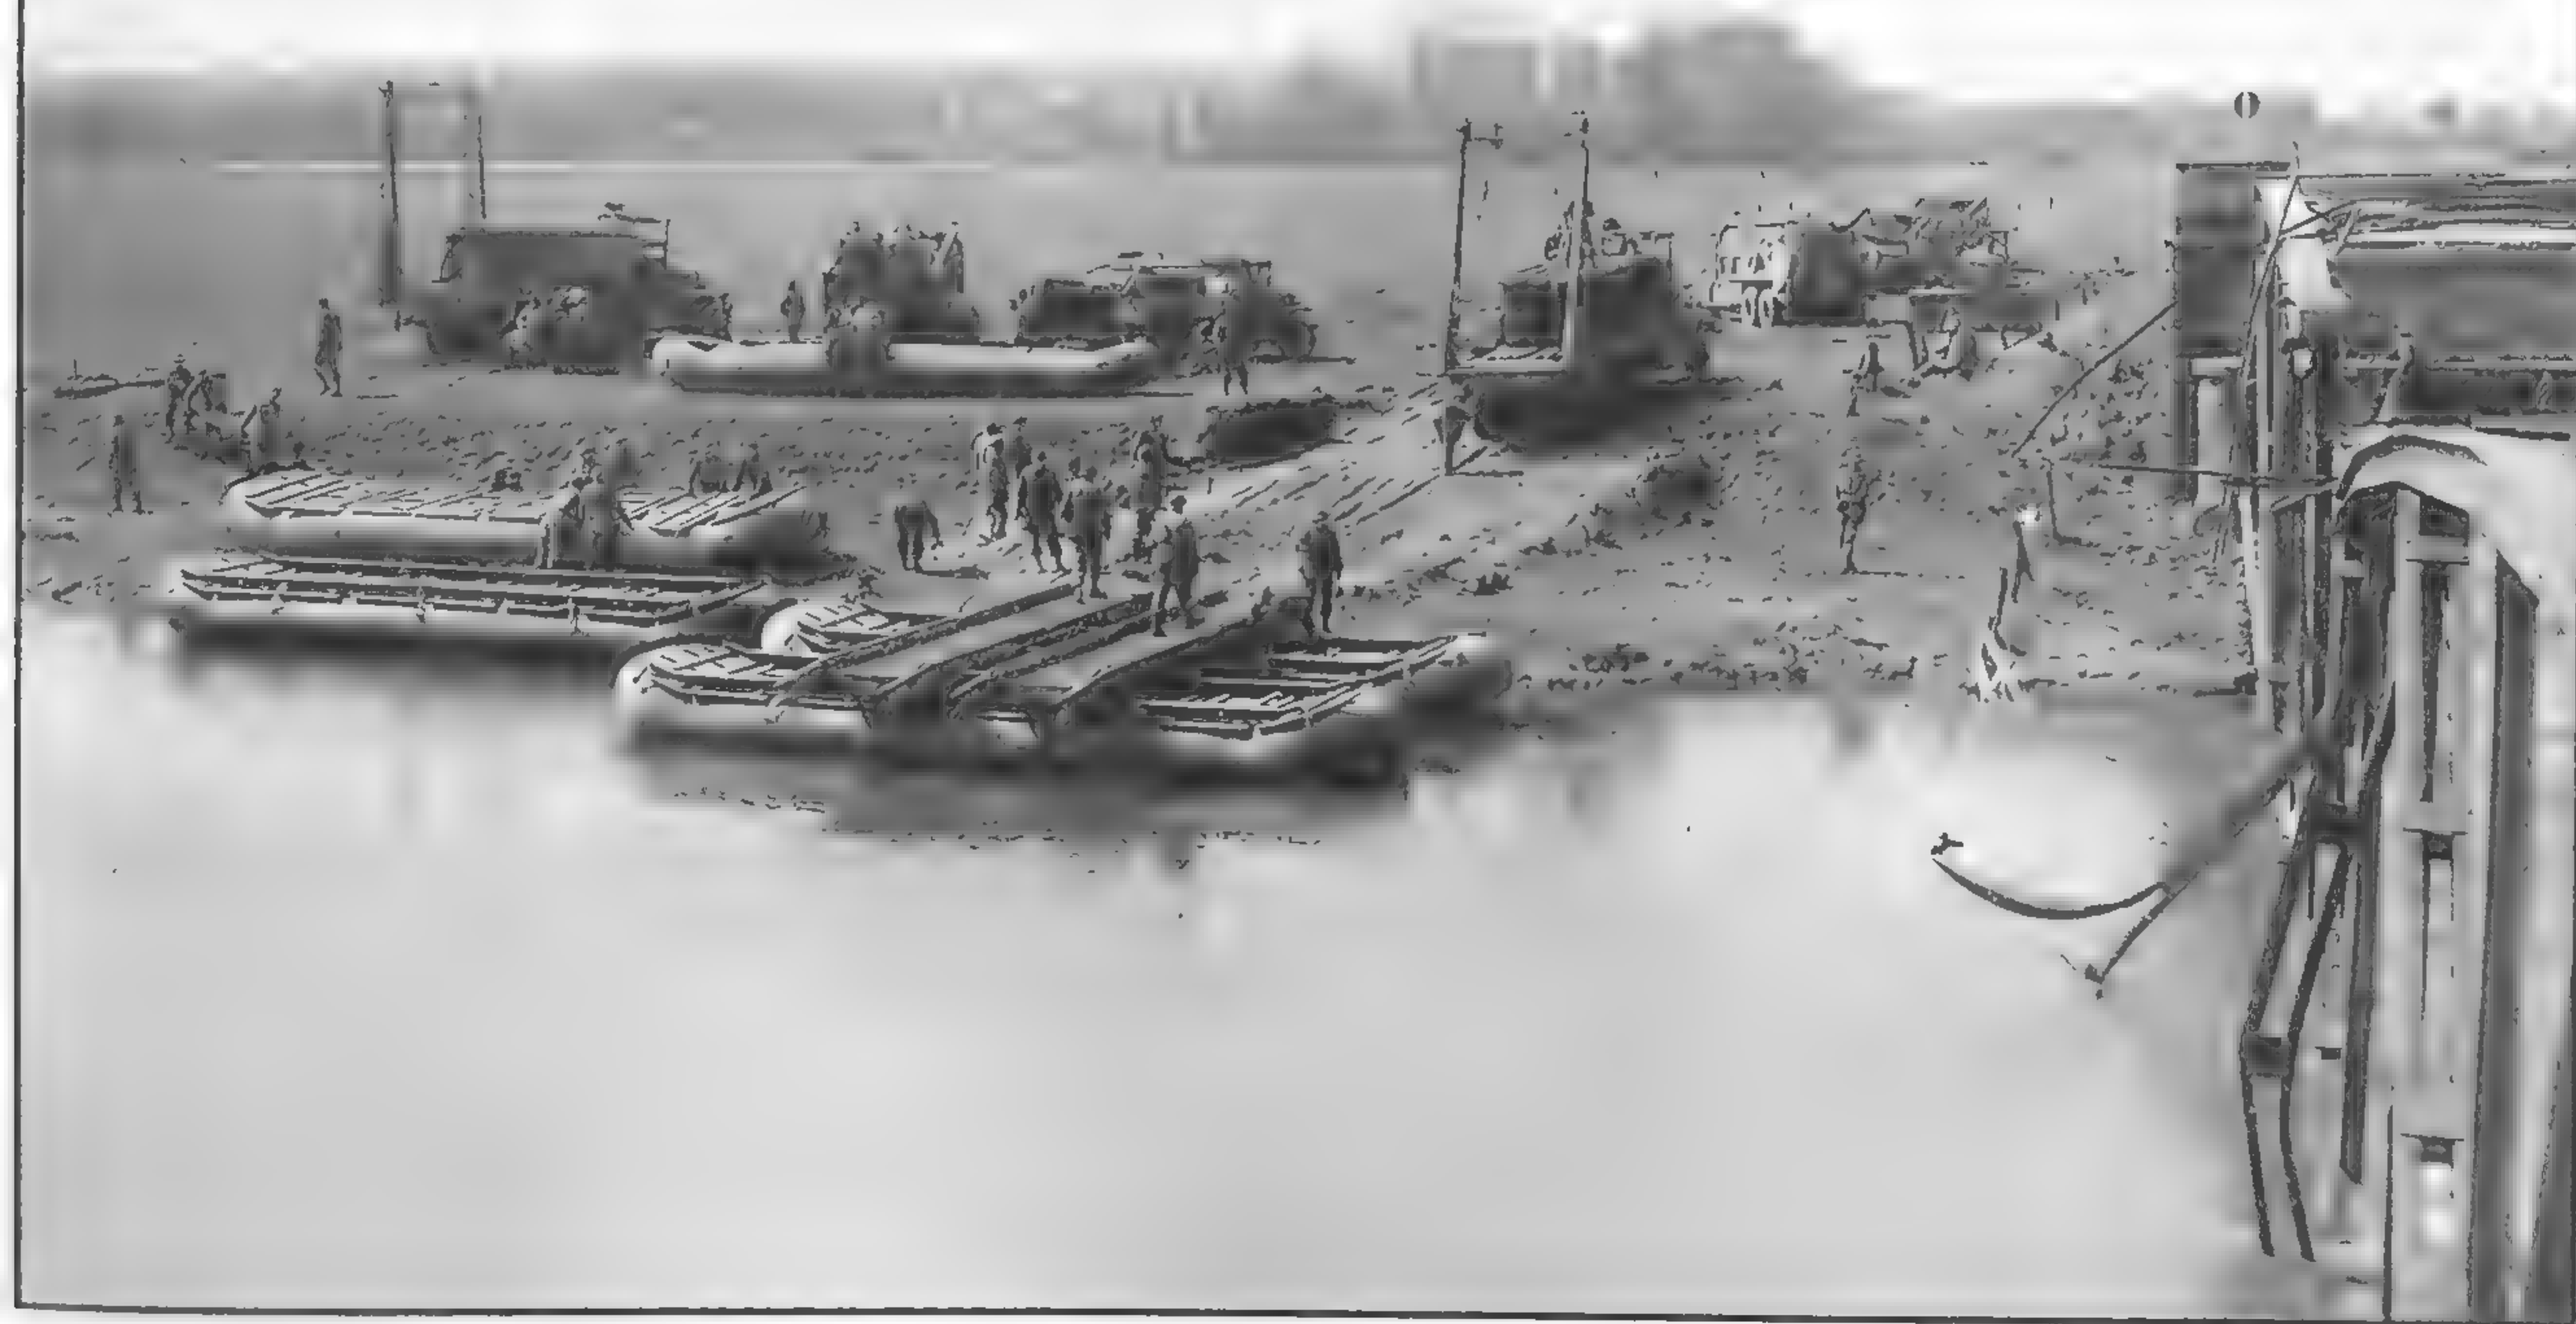
A follow-up photo with six pontoon sections assembled and in position. Engineers are manhandling the raft with saddle into the river while the truck brings out the Treadway flooring. The steel Treadway section weighs 2,350 pounds and has an effective length of 12 feet and a clear track width of 45 5 inches. The M2 Bridge was designed to support medium tanks and other heavy vehicles. (NARA)

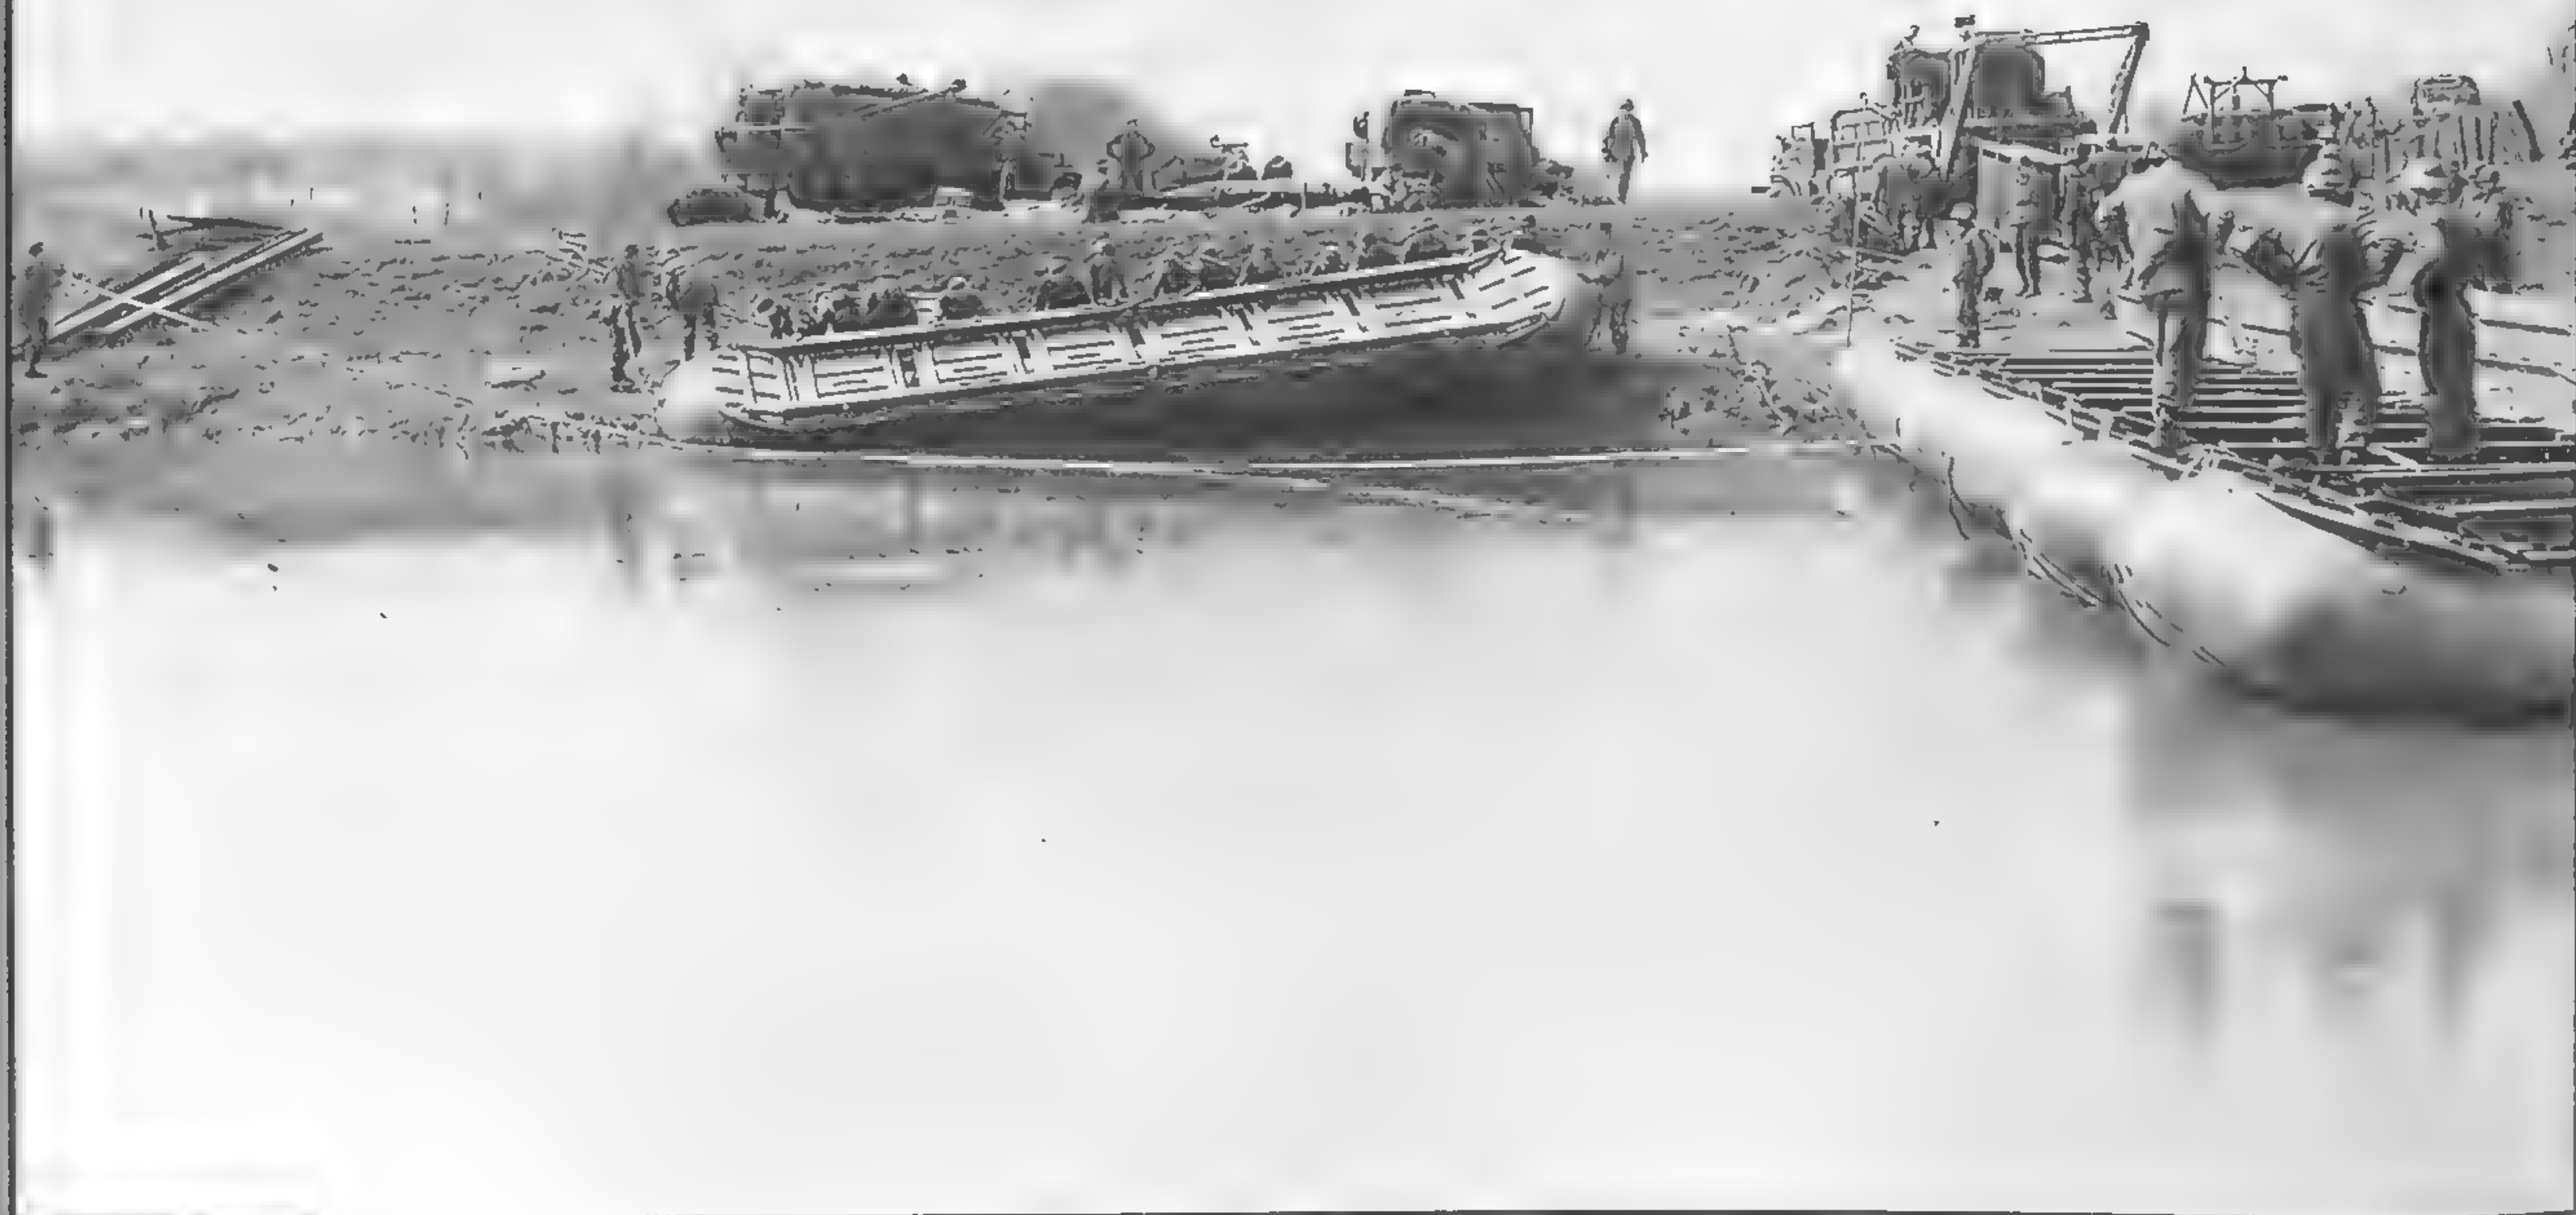
A view from the bed of an erector truck showing engineers passing Treadways onto the saddle beams. They were locked in place by Treadway retainer clamps. References show different patterns of flooring on the steel Treadways but the "I-beam-lok" flooring shown is the most common. Note the separator/spreader bar holding the Treadway handling chains apart. (NARA)
